2012 ROARING FORK WATERSHED MANAGEMENT PLAN

ROARING FORK WATERSHED MANAGEMENT PLAN

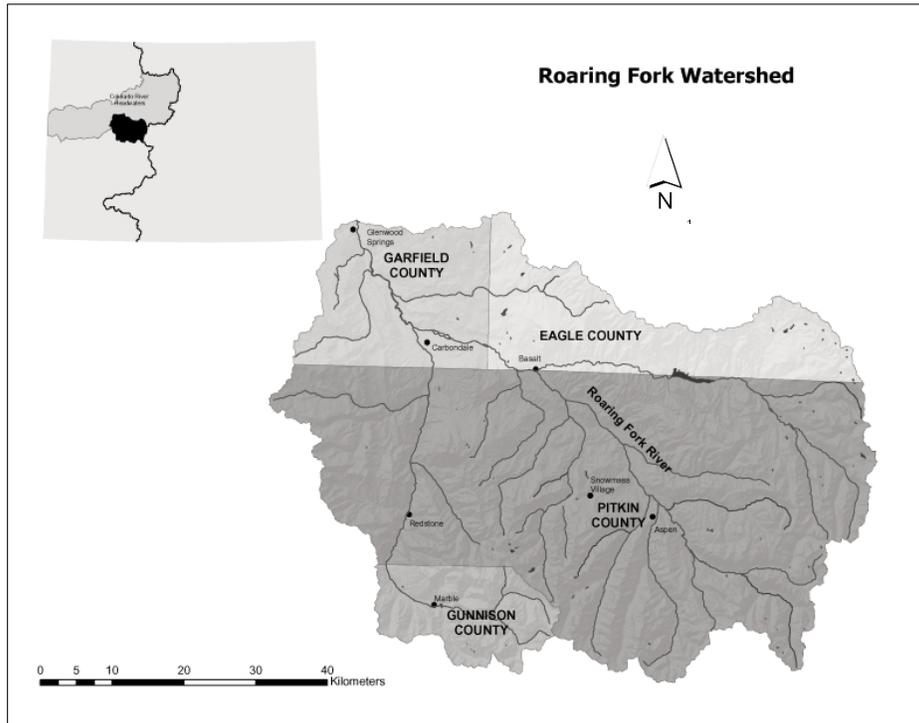
Figure RF-1. Roaring Fork Watershed Map.

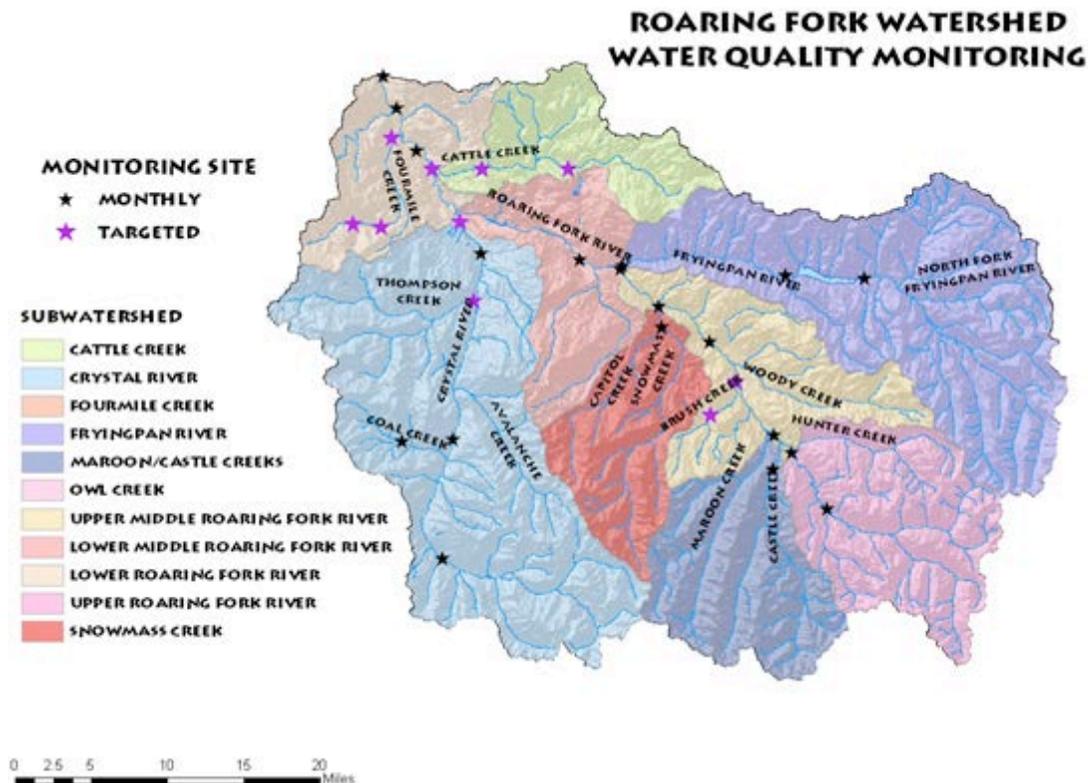
Figure RF-2: The Roaring Fork Watershed Water Quality monitoring sites (2008)

Roaring Fork State of the Watershed Report, RFC).

In 1999, the Roaring Fork Conservancy initiated a watershed water quality monitoring program, modeled after the Colorado Division of Wildlife's River Watch program. The program uses existing River Watch efforts and oversees/ coordinates numerous "stream teams". Currently, sampling is conducted at 28 sites around the watershed including numerous sites along the Roaring Fork as well as many of its tributaries (Roaring Fork Conservancy, 2011).

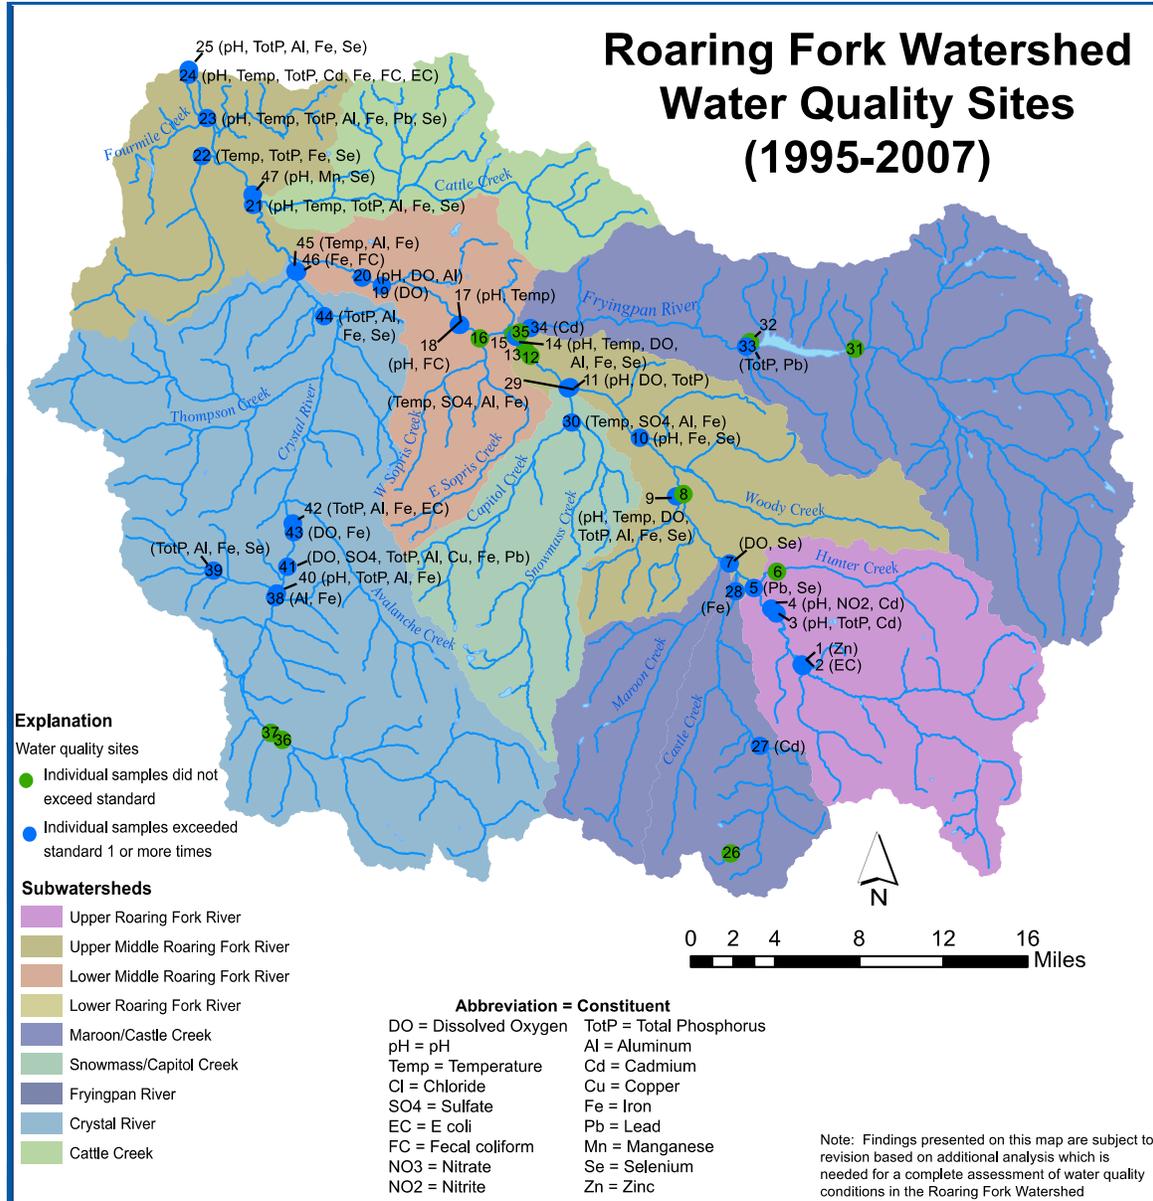
In the figure below, water quality sampling data has been graphically summarized for the

period from 1995-2007 recently by the Roaring Fork Conservancy in the 2008 Roaring Fork State of the Watershed Report. The findings presented are subject to revisions and additional analysis. For instance, an individual sample exceeding water quality standards more than once does not indicate a summary trend or the significance of any constituent or reported values.

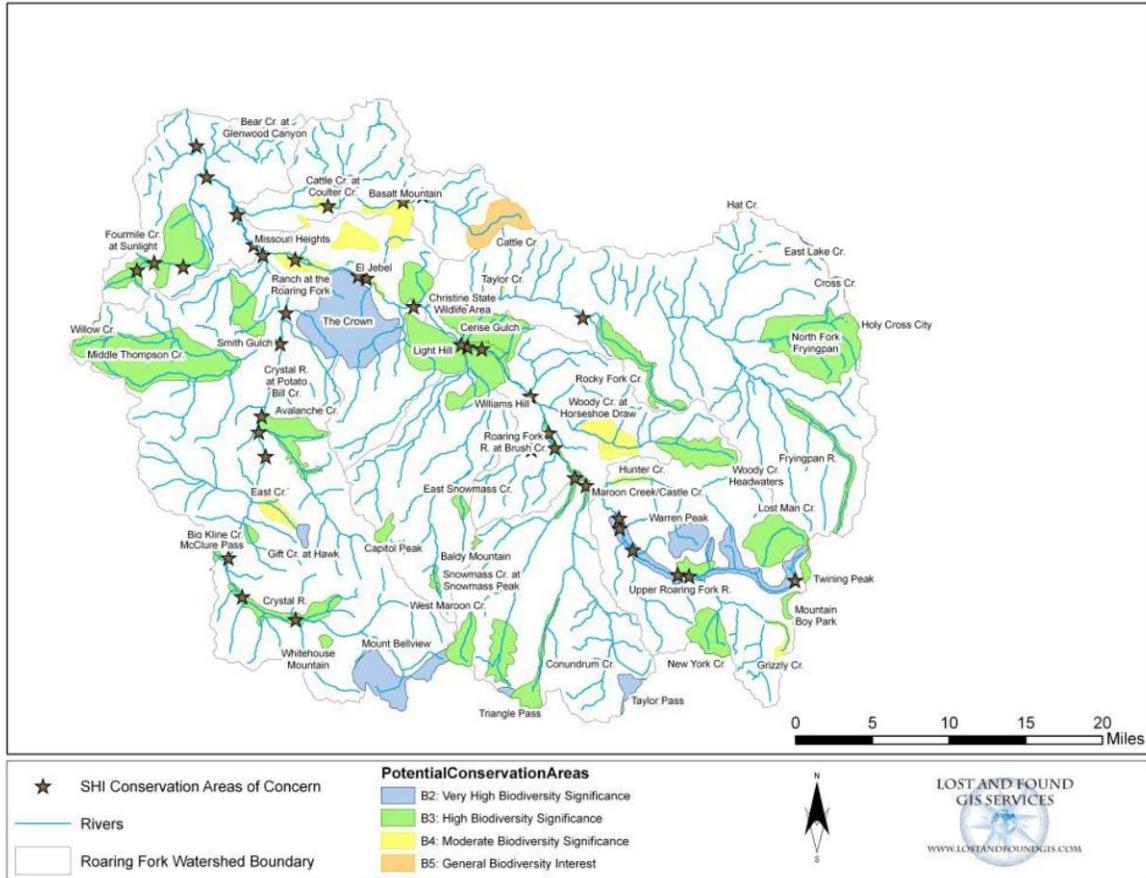
Figure 3.3.2. CNHP Potential Conservation Areas (PCA) and SHI Conservation Areas of Concern (CAC) in the Roaring Fork Watershed (Source: Spackman et al., 1999 and Malone and Emerick, 2007a).
